Focussed Improvement Team Saves € 216,000

Saint Gobain Gypsum Chambery, France.

Wall partitioning system – Component assembly operation.
Material yield improvement project.

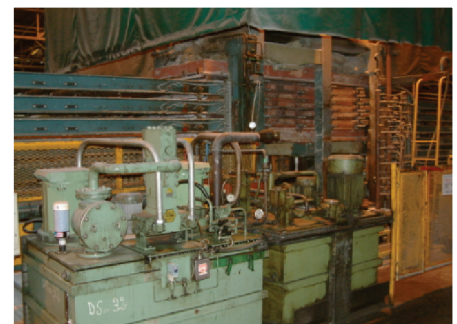
Photo 1 - Press section of wall partitioning area.
